PASSAIC RIVER BASIN
WANAQUE RIVER, PASSAIC COUNTY
NEW JERSEY

⁽²⁾ RAYMOND DAM

PHASE I INSPECTION REPORT
NATIONAL DAM SAFETY PROGRAM

⁽³⁾ (NJ 00213)

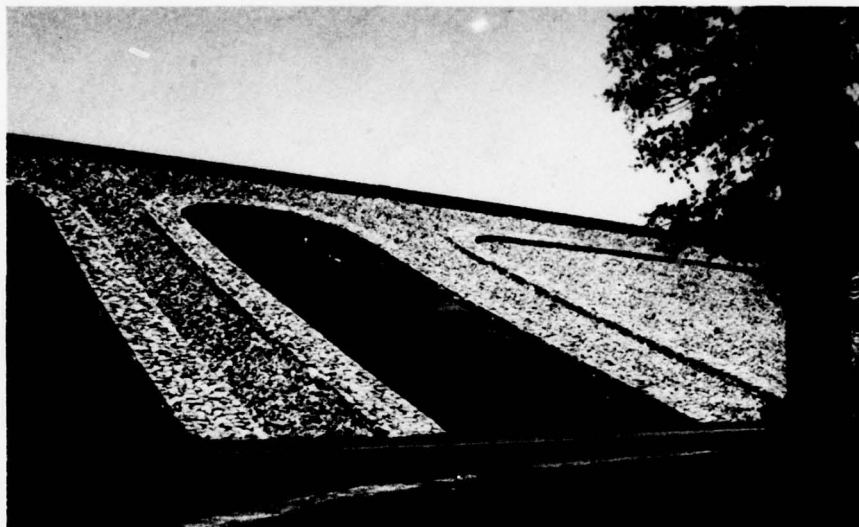
MOWING OF GRASS NEAR LEFT ABUTMENT BY RESIDENT MAINTENANCE CREW

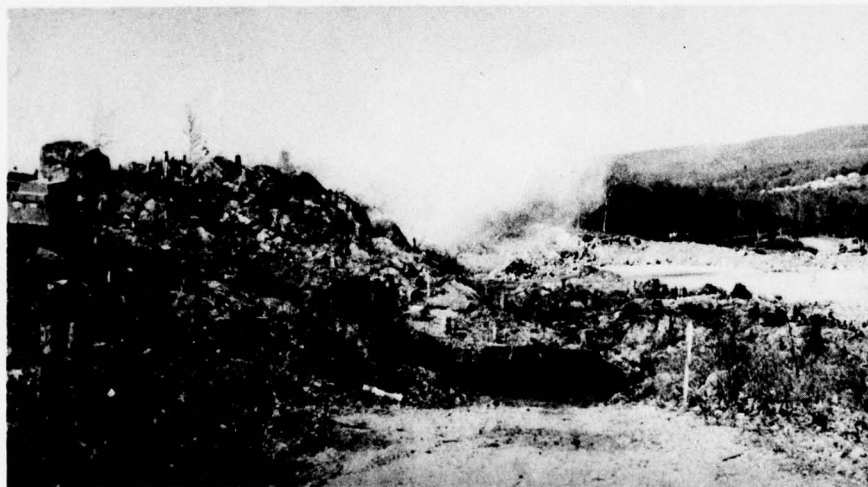
DUST FROM BLASTING AT NEW FILTRATION PLANT SITE 0.3 MILES
SOUTHWEST OF DAM - VIEW LOOKING NORTHEAST

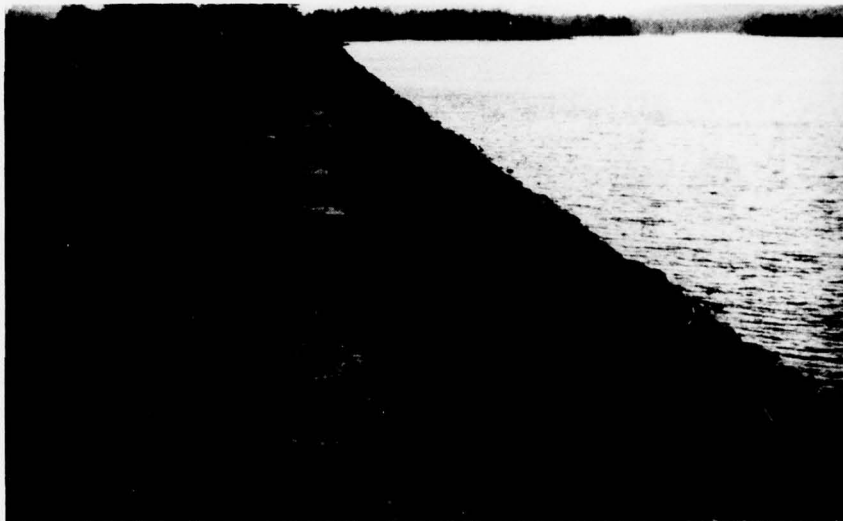
NOTE UNIFORMITY OF RIPRAP AND HORIZONTAL ALIGNMENT

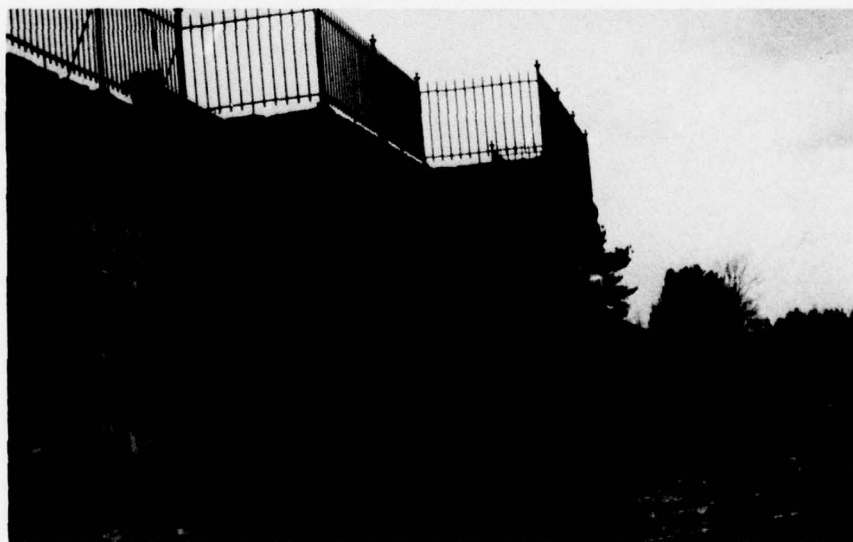
3.1.3 Appurtenant Structures: There was some surface scaling and deposits on the reservoir side of the Upper Gate House. The conduits were full of water and could not be inspected. Repairs were being made to the gate hoist mechanisms in the Upper Gate House at the time of the inspection. According to a representative of the owner, the gates were operated after a thick layer of deposits had built up on the stems and resulted in some twisting-off of retaining brackets for the stem.

SURFACE DETERIORATION AT UPPER GATE HOUSE

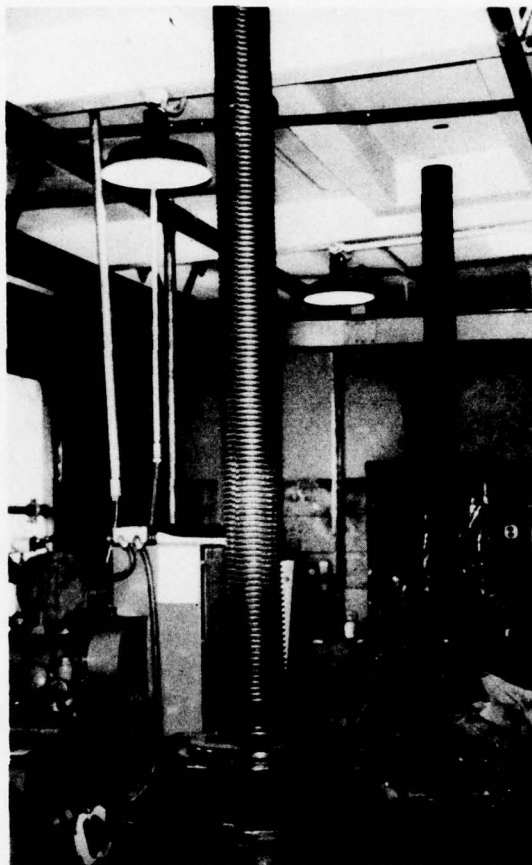
UPPER GATE HOUSE - TWO GATE
OPERATORS ON RIGHT

At the time of the inspection, 5/11/78, all four gates were inoperable due to corrosion in the stem guide at each gate. Two of the gates were in the process of having their corroded brass stem guides replaced with stainless steel. The remaining two gates are scheduled to have their guide replaced after completion of the work on the first two.

7.2.2 Operations and Maintenance Procedure: It is recommended that a monthly maintenance operating schedule be enacted soon to operate each of the four gates in the Upper Gate House through a complete close-open cycle.

It is recommended that a monthly maintenance operating schedule be installed to operate each of the four sluice gates through a complete close open cycle. This will show that all electrical, mechanical and hydraulic components of the gate system are in operating condition.
